DTI REPORT NO. 655

# HEAVYWEIGHT HIGH IMPACT (H.I.) SHOCK TEST REPORT

# **EQUIPMENT INCREMENT E (SSEE-E) SYSTEM FOR 901D**

# July, 2003

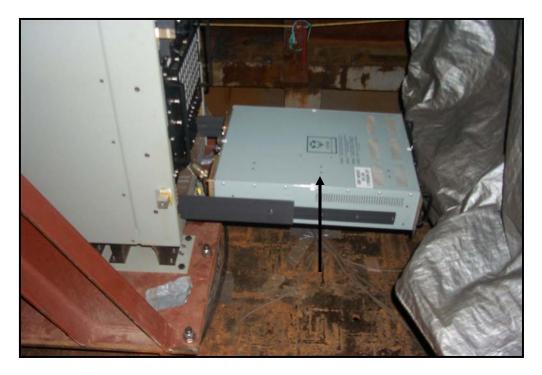
Photograph No. 8. New UPS

**NOTE 1:** The UPSs on only two of the four cabinets were operational during the first two shots. The on-site Argon representatives installed new ones, as seen in Photograph Nos. 8 and 9.

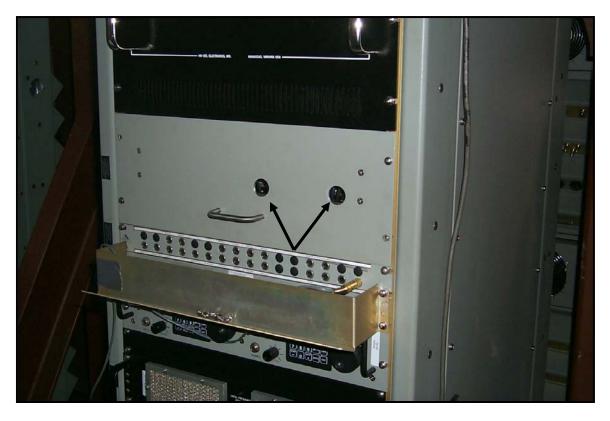
Photograph No. 10. Modification to KVM Cover

**Observation 1:** The KVM and keyboard were not operational in the System Control Rack.

**Observation 1:** The KVM and keyboard was not operational in the System Control Rack.

**NOTE 2:** To enable the operator of the rack to reset the KVM, the cover was removed and modified, as seen in Photograph No. 10. Two 1-inch holes were drilled into the cover to allow for operator reset.
