DTI REPORT NO. 655

# HEAVYWEIGHT HIGH IMPACT (H.I.) SHOCK TEST REPORT

# **EQUIPMENT INCREMENT E (SSEE-E) SYSTEM FOR 901D**

# July, 2003

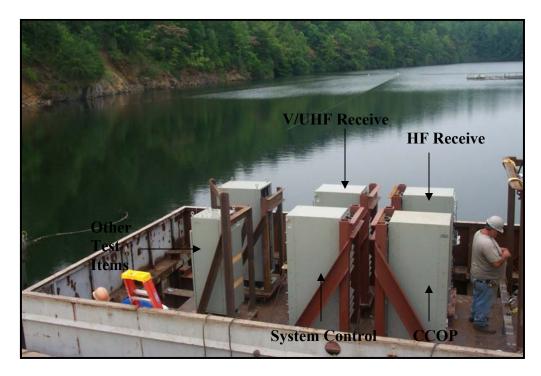
Photograph No. 1. Overhead View of Initial Installation, Shots 1-3

Photograph No. 1 shows the installation for Shots 1 through 3.

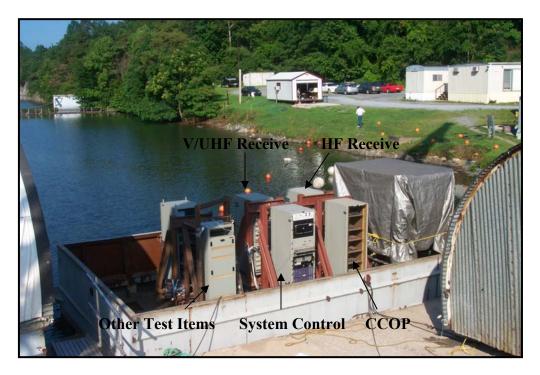
Photograph No. 2. Overhead View of Initial Installation, Shot 4

Photograph No. 2 shows the installation for Shot 4.

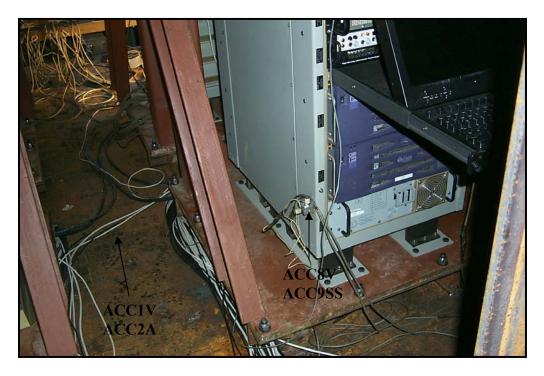
Photograph No. 3. Instrumentation Locations

The fundamental vertical response of the DSF was determined from the peak response on a fast fourier transform (FFT) generated from acceleration timehistory data measured at Sensor A1V (see Photograph No.3). Deck frequency and support locations are summarized in Table 2.
